Manhole Inspection Summary

Manhole # S69M__019MH

Insp Date: **1/29/08 9:15 AM**

Location Address: **6700 Graceland Ave.**

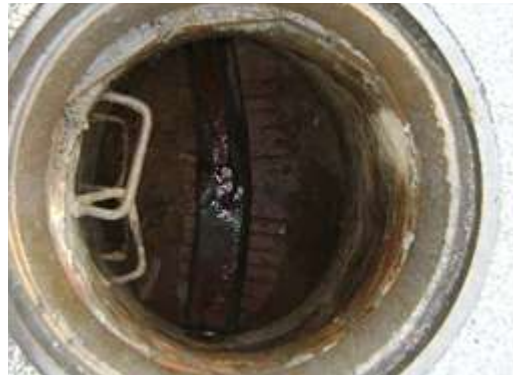
Top View

Frame Offset: **1** (in.) Condition: ☐ Sound ☐ Cracked ☒ **Leaks**

Condition: ☐ Sound ☐ Cracked ☐ Root Intrusion ☒ **Loose Brick** ☐ Deteriorated

Infiltration: ☐ None ☒ **Joint** ☐ Cracks ☒ **Mortar** ☐ Roots ☐ Wall
